### Inspection Report

#### Minerals Regulatory Program

**Mine Name:** Torrey Quarry  
**Operator Name:** Star Stone Quarries

**Permit number:** M/055/0016  
**Inspection Date:** August 28,  
2012  
**Time:** About 5:00-5:20 PM

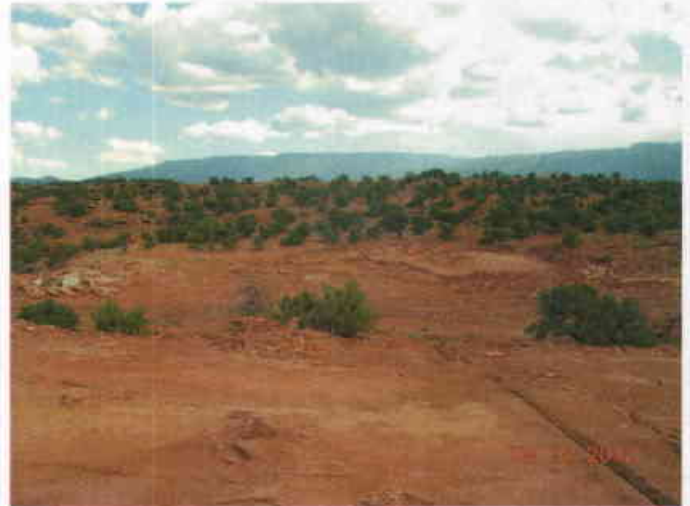
Photo 3. This and Photo 4 are overviews of part of the area being mined.

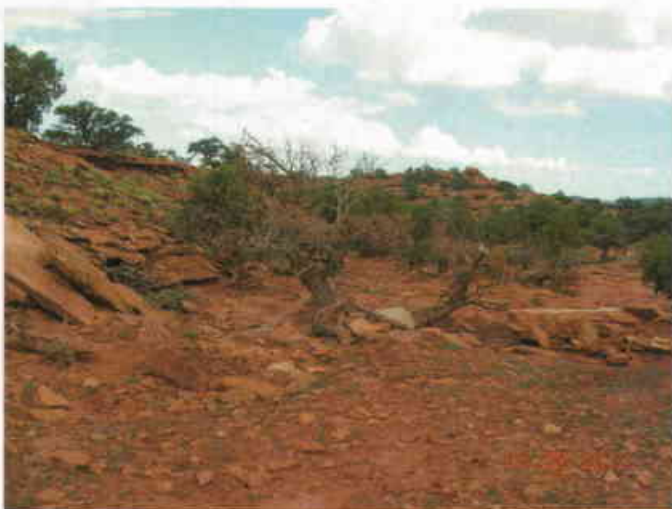
There had obviously been a substantial rain storm, and about half of the check dam has washed away. It needs to be re-built.

Photo 2. The portion of the check dam that was washed out is in the left center portion of this picture.

The check dam needs to be re-built. This needs to be done before the next inspection.
